Manhole Inspection Summary

Manhole # S35WW1027MH

Insp Date: **1/30/07 11:16 AM**

Location Address: **320 BROADMOOR RD** Cross Street: **WILLOWMERE WAY**

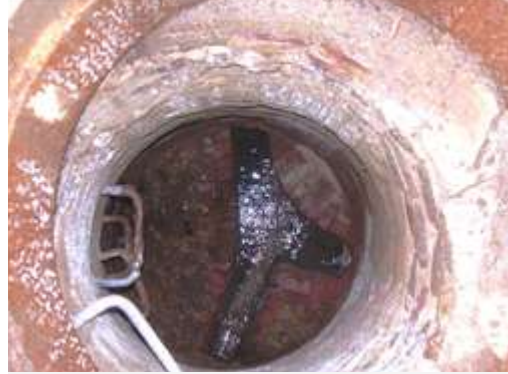
Top View

Corroded steps. Evidence of surcharge - Bench debris. Channel debris.

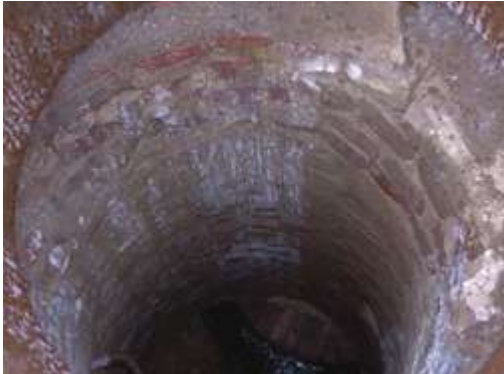
Defect

Frame offset. Adjustment deterioration, cracks and infiltration. Corbel infiltration.

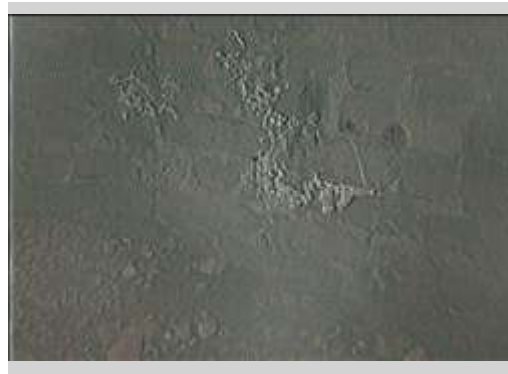
Defect

Barrel deterioration, root intrusion and infiltration.

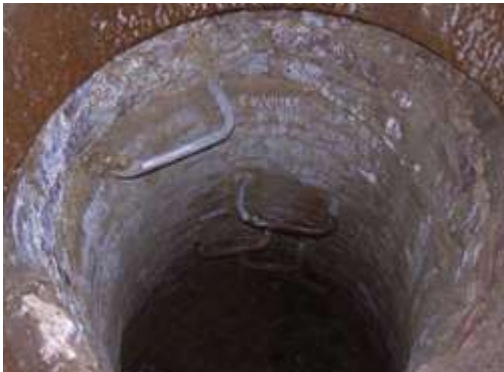
Defect

Frame offset. Adjustment deterioration and infiltration. Corbel infiltration.

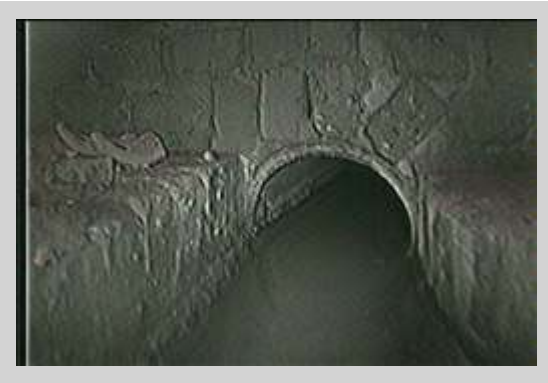
Pipe Out @ 12 O'Clock

Barrel deterioration and infiltration.

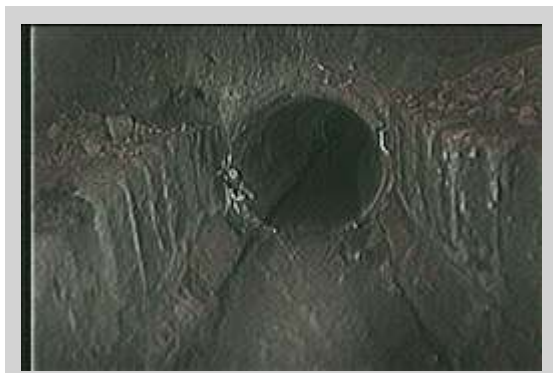
Pipe In @ 7 O'Clock

Channel deterioration.
